Non-Structural Vulnerability Assessment of Hospitals in Nepal

**National Society for Earthquake
Technology-Nepal**

December 2003

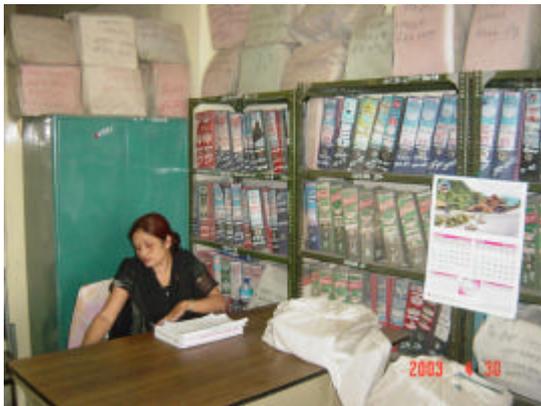
Photo 1: These document packs stored on the top of book shelves and cupboards are a life safety hazard.

Fig 1: Life safety hazards can be reduced just by removing less important things from the working place.

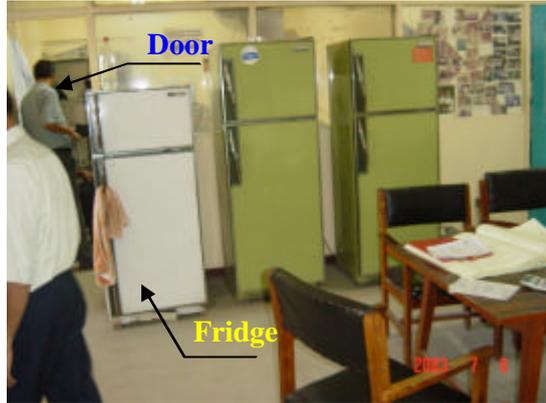
Photo 2: The fridge kept near an exit door is a life safety hazard.

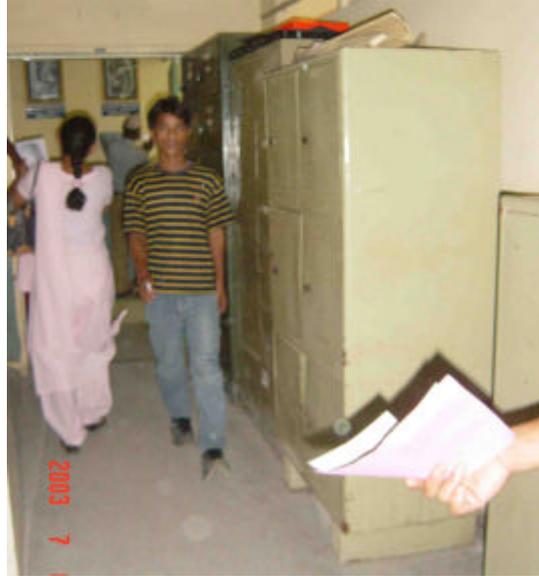
Photo 3: These cupboards can block the corridor and are a life safety hazard.

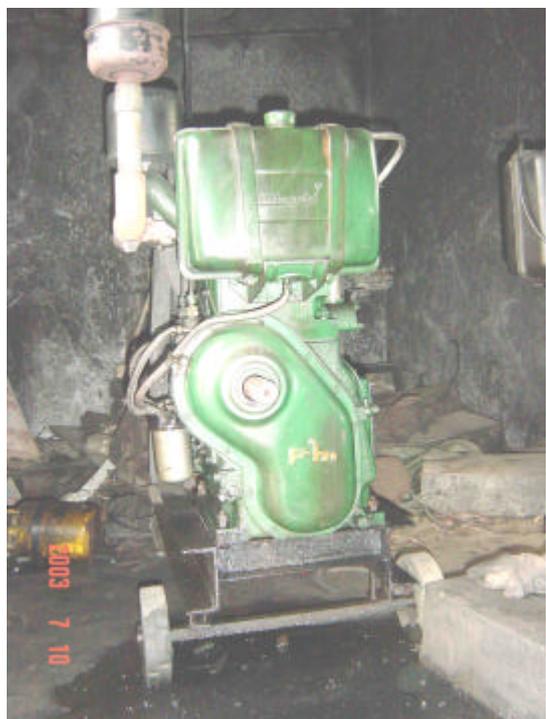
Photo 4: A generator on rollers can slide and overturn in an earthquake causing functional loss.

Fig 2: Generators and other vibrating equipment can be fixed by special brackets, which allow some movement but prevent them from overturning.

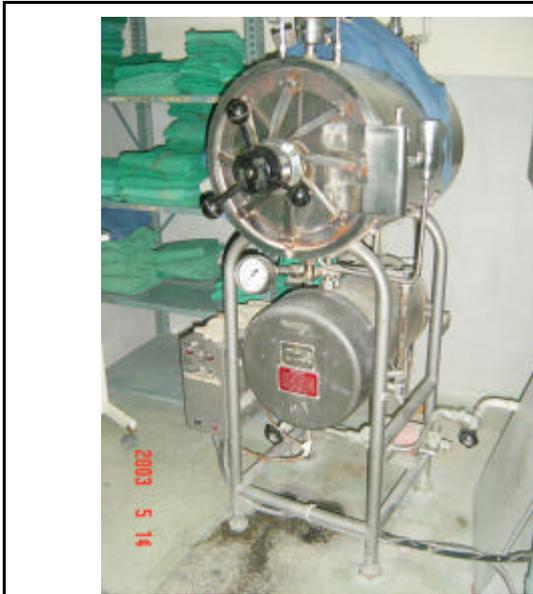
Photo 5: Autoclave machine without anchorage.

Fig 3: This machine can be fixed to the floor by casting a concrete base.

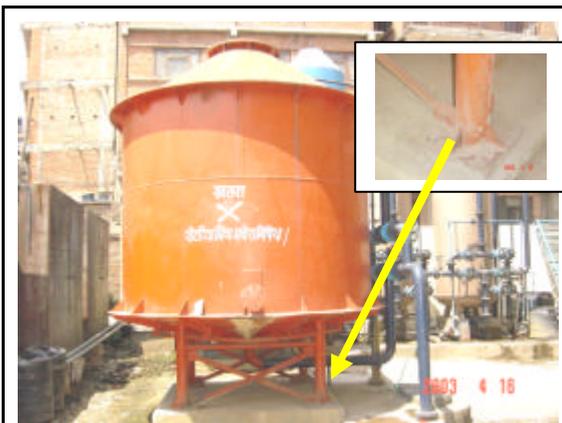
Photo 6: Water treatment tank which has a provision for bolting at the base but was found not bolted.

Fig 4: Bolting at the base can prevent overturning of heavy objects during an earthquake.

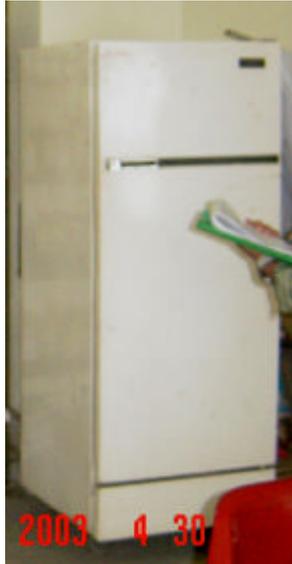
Photo 7: Tall and narrow objects like fridges can easily overturn during earthquakes.

Fig 5: Such objects can be protected from overturning by bolting them to the wall.

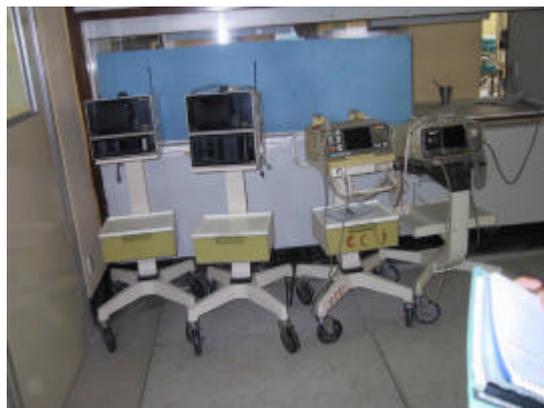
Photo 8: ECG monitors on rollers with potential risk of sliding and overturning.

Fig 6: Provision of chains on the wall to hook such machines.

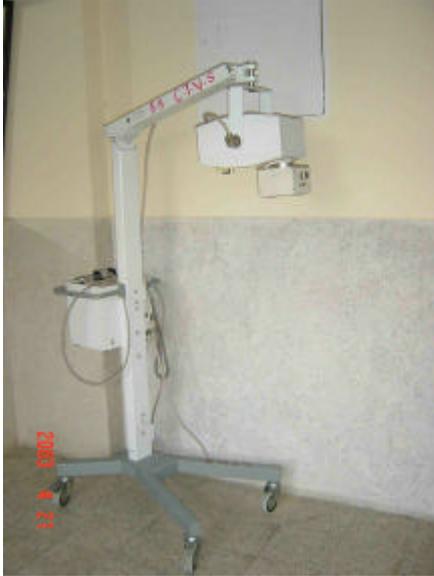
Photo 9: Mobile X-ray on rollers.

Fig 7: Hooking of mobile X-ray to the wall.

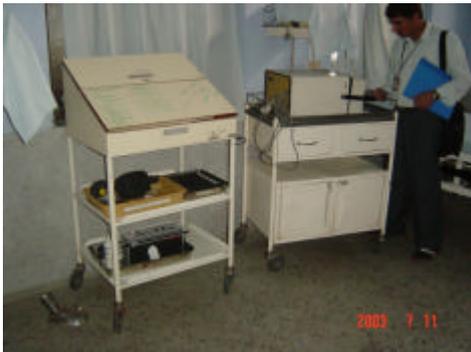
Photo 10: Resuscitation equipment on roller trolleys.

Fig 8: Hooking of the trolley and strapping of the equipment.

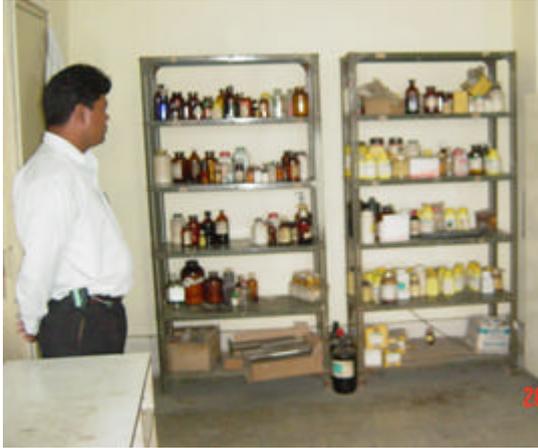
Photo 12: Chemical and medicine bottles on shelves pose a risk of falling.

Fig 10: Strapping the shelves by nylon rope after anchoring the rack to the wall is an easy way of making these bottles safe.

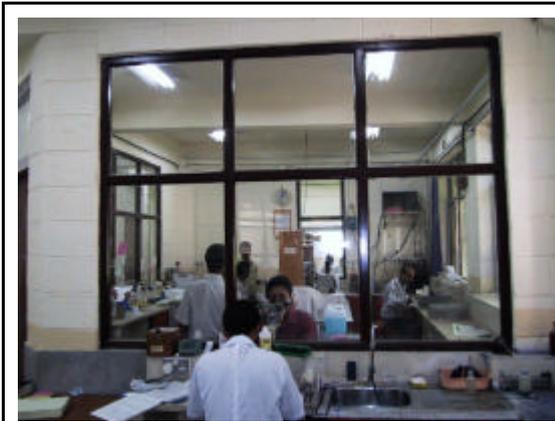
Photo 16: This window glass can cause a life safety hazard.

Fig 12: Simple plastic lamination can protect lives.

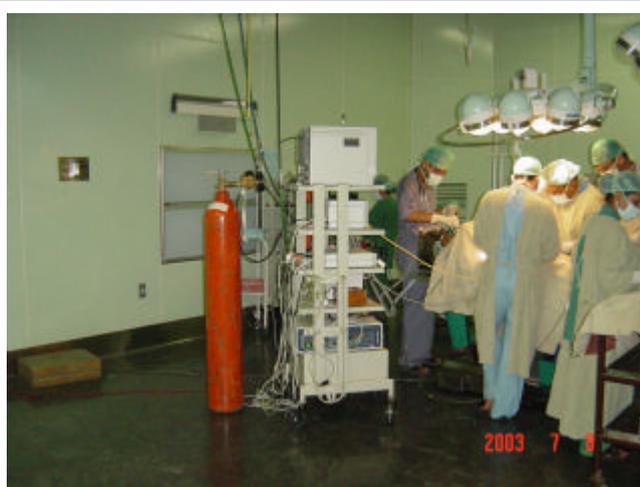
Photo 17: Most equipment is on roller trolleys (equipment racks) in operation theatres. The risk of falling down is high.

Fig 13: Tying all equipment to a steel frame can improve the situation.

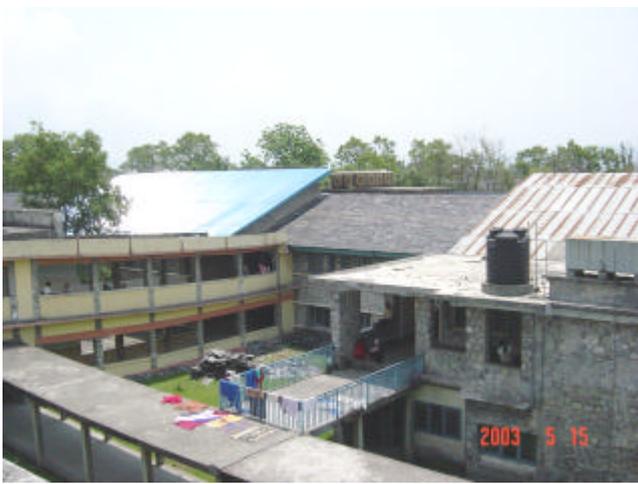
Photo 1: Buildings of different height, shape and structural properties connected with each other can cause severe pounding during earthquakes.

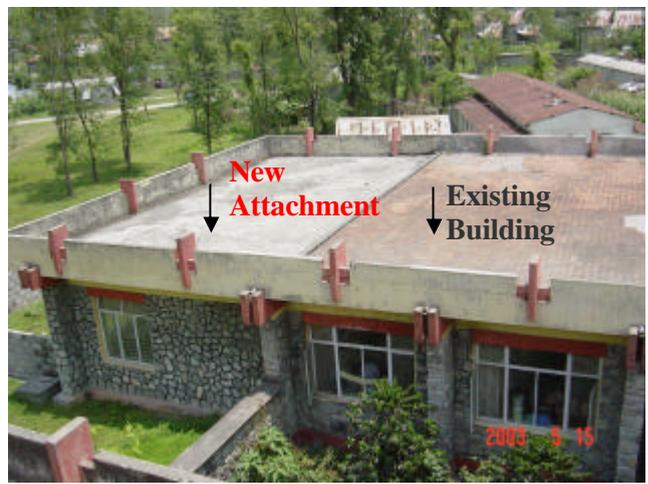
Photo 2: A new attachment to existing buildings with no seismic gap has made both the existing and the new building vulnerable.

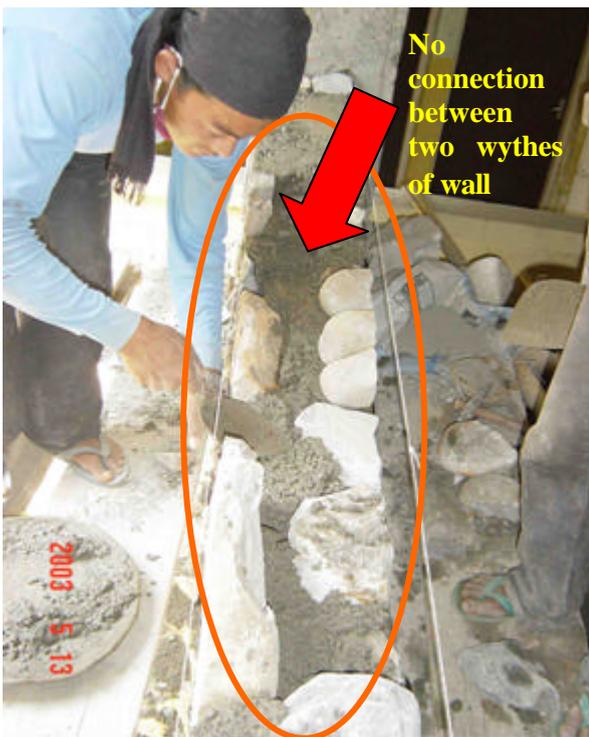
Photo 3: A stone masonry infill wall construction in the new building. There is no proper connection between the stone units making it a very vulnerable wall. The mortar used is 1:6 cement: sand mortar.

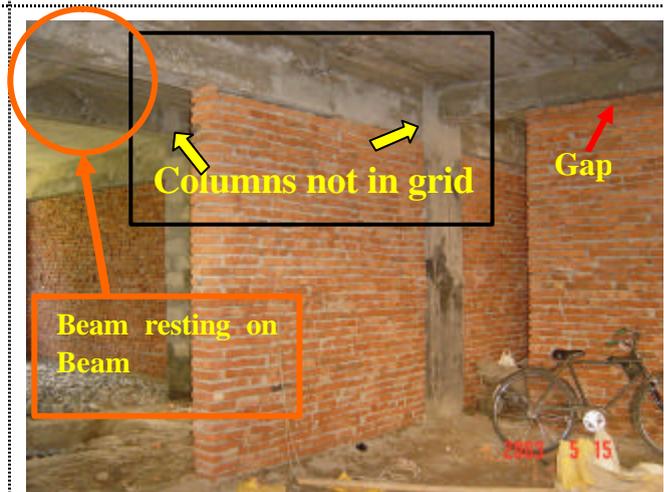
Photo 4: The structural system and load path of the new building is not proper. The columns are not in grid, beams are just connected with beams and there is a lack of columns. Improper connection of infill walls with the frame has made the infill walls more vulnerable.

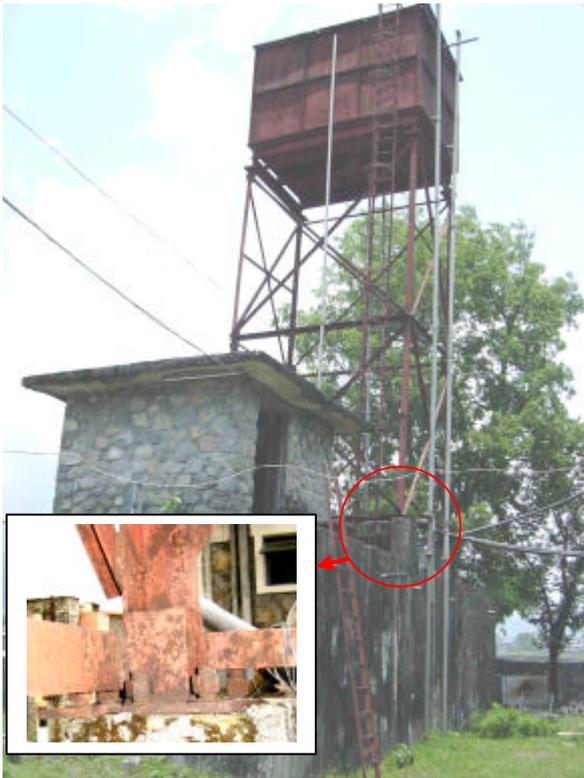
Photo 5: The base of an overhead tank; the bolts are not properly fixed and are rusted, the base is weathered.

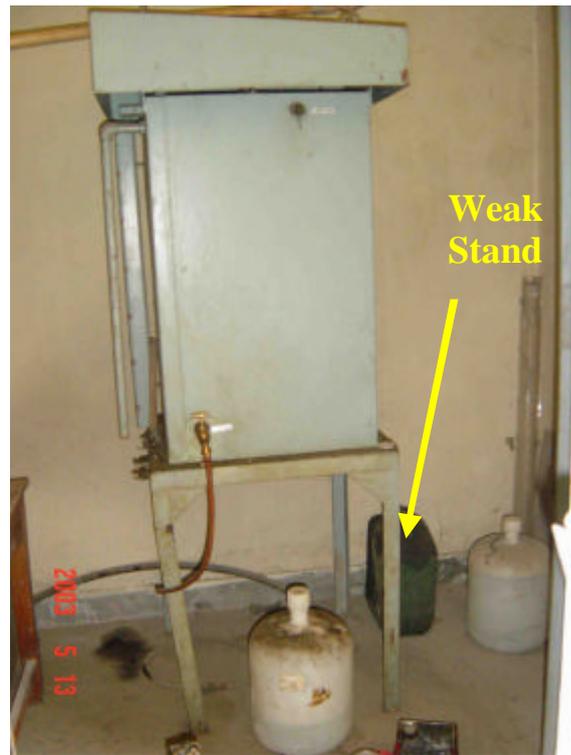
Photo 6: 300 litres fuel tank of the generator; on a weak stand without anchorage and lateral support.

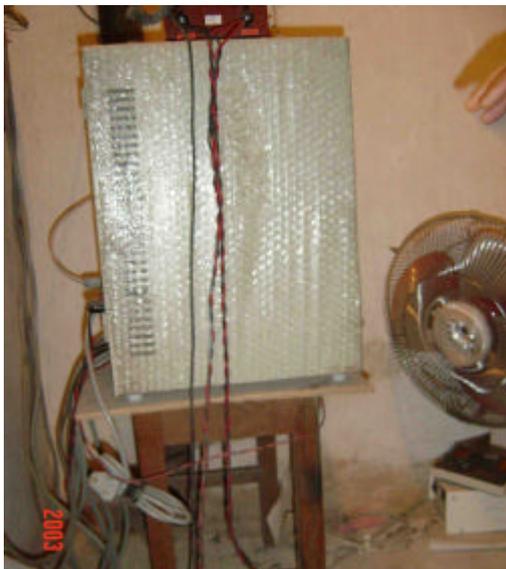
Photo 7: Communication equipment on a temporary type stand. It needs a proper stand with anchorage and fixing.

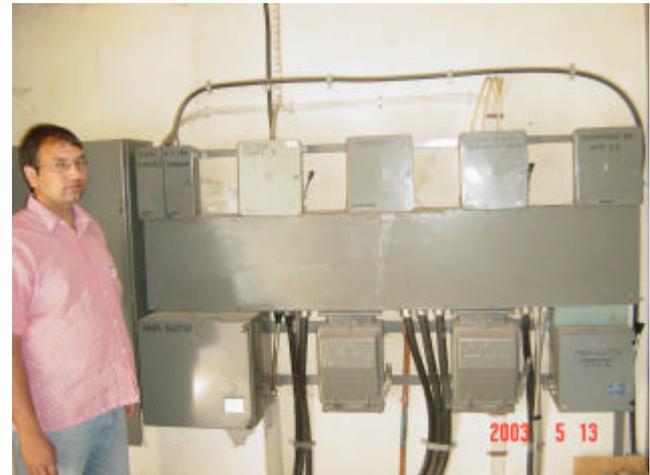
Photo 8: The main board for electricity distribution within the hospital; properly anchored on the wall and with low vulnerability.

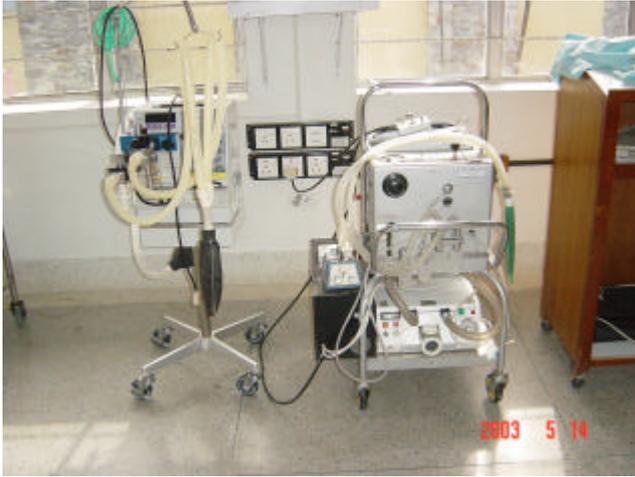
Photo 9: Equipment on rollers in the operation theatre and other places is vulnerable as it may roll and impact with other objects.

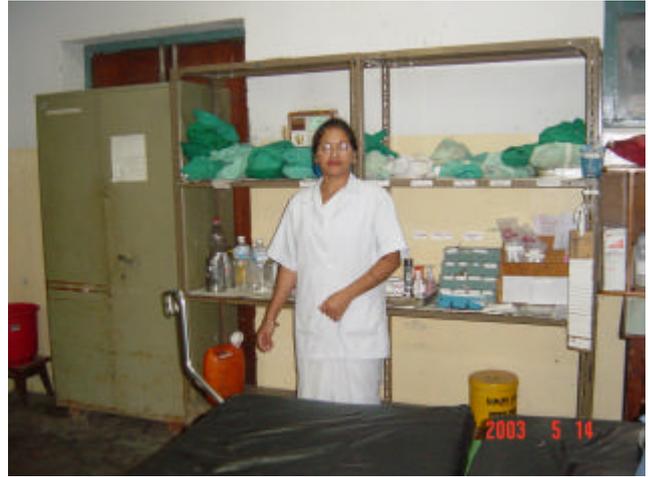
Photo 10: Cupboards and racks storing important equipment, medicines and chemicals are vulnerable because they are not fixed to the wall and strapped.

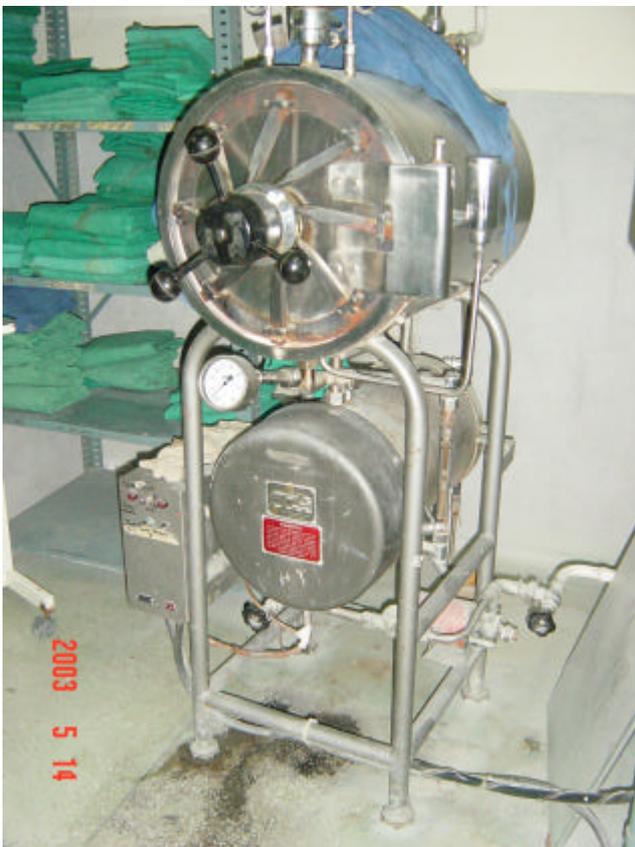
Photo 11: Autoclave machine needs anchorage at the base.

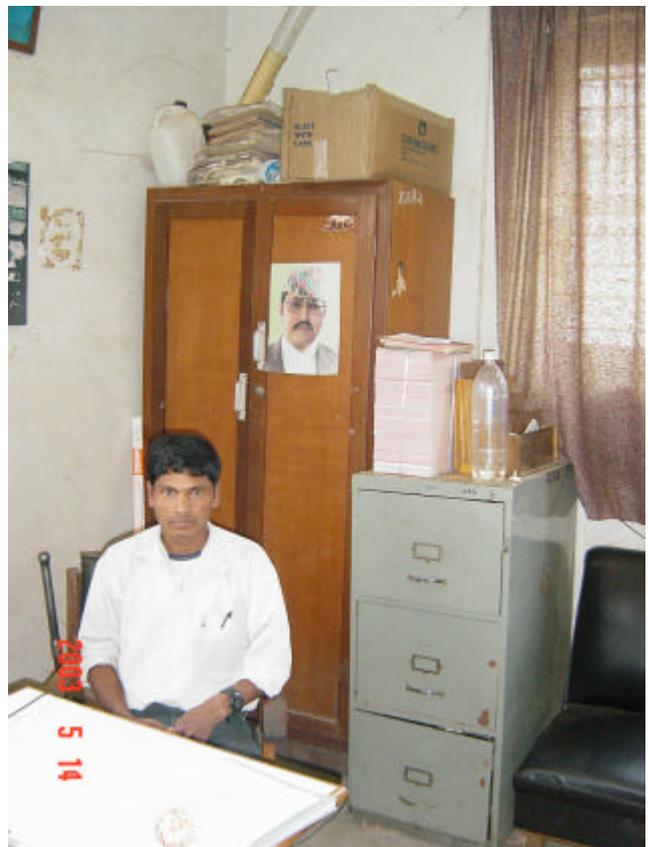
Photo 12: The cupboards and racks near working stations in the administration and other places of the hospital can be life safety hazards.

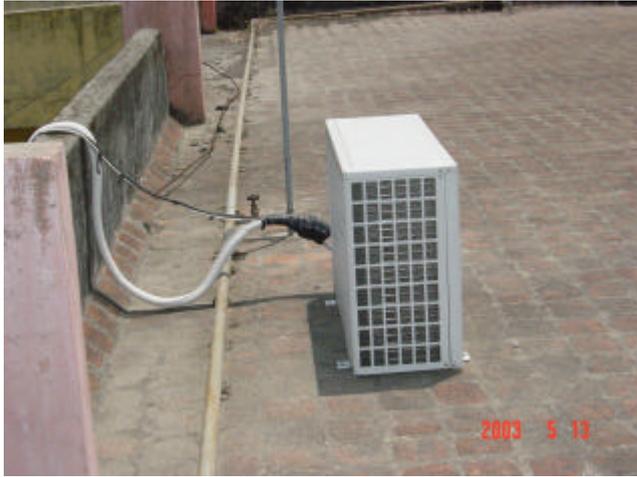
Photo 13: The air conditioning equipment for the OT is kept on the roof with no fixing.

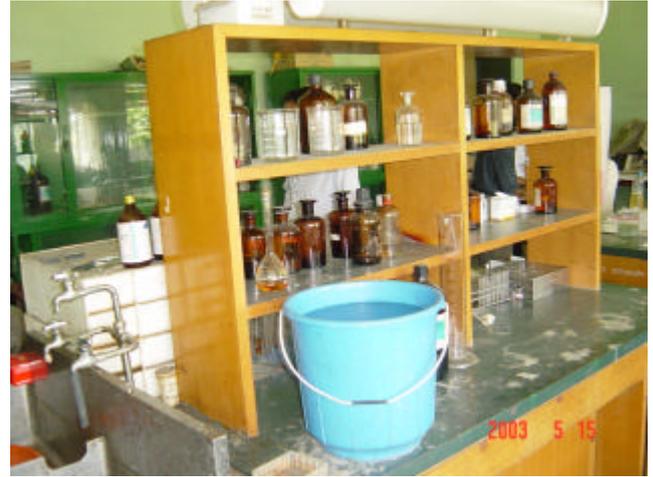
Photo 14: Racks containing chemicals in laboratories should be anchored; chemical bottles should be strapped or relocated to improve safety conditions.

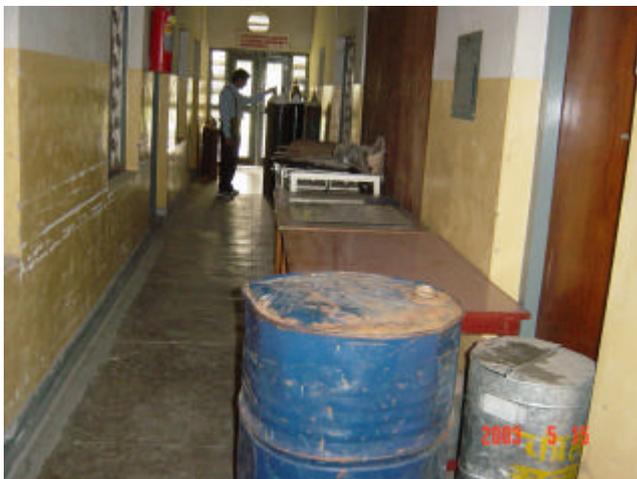
Photo 15: Cupboards and other objects in the corridors can block the exit ways during earthquakes.

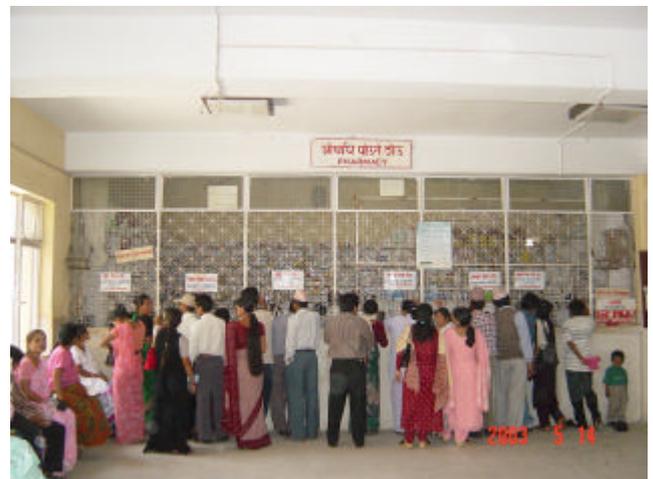
Photo 16: Window glasses or glass partitions are life safety hazards and need plastic lamination.
