Non-Structural Vulnerability Assessment of Hospitals in Nepal

**National Society for Earthquake
Technology-Nepal**

December 2003

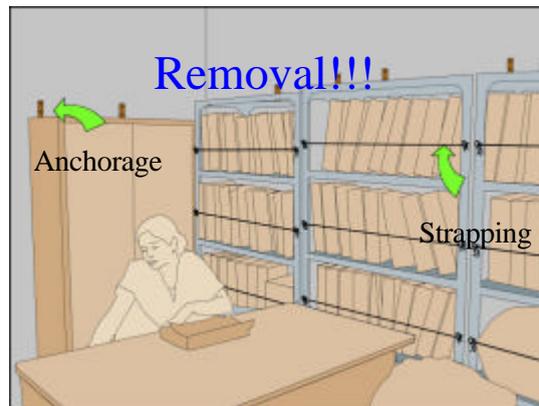
Photo 1: These document packs stored on the top of book shelves and cupboards are a life safety hazard.

Fig 1: Life safety hazards can be reduced just by removing less important things from the working place.

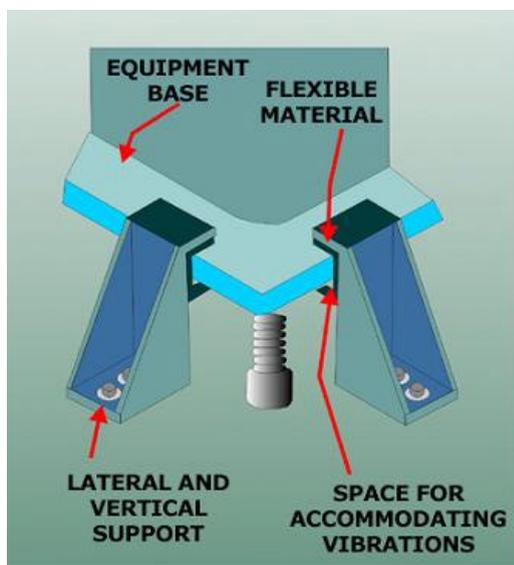
Photo 4: A generator on rollers can slide and overturn in an earthquake causing functional loss.

Fig 2: Generators and other vibrating equipment can be fixed by special brackets, which allow some movement but prevent them from overturning.

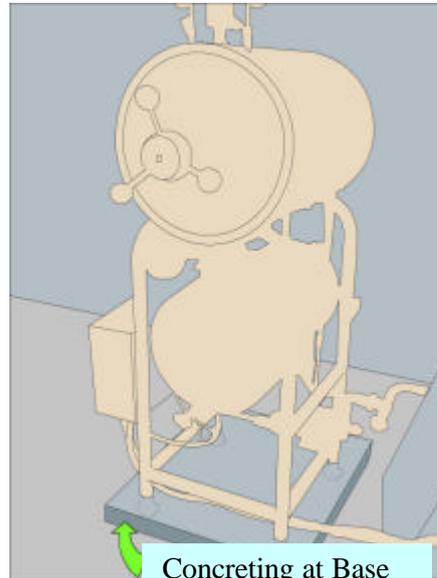
Photo 5: Autoclave machine without anchorage.

Fig 3: This machine can be fixed to the floor by casting a concrete base.

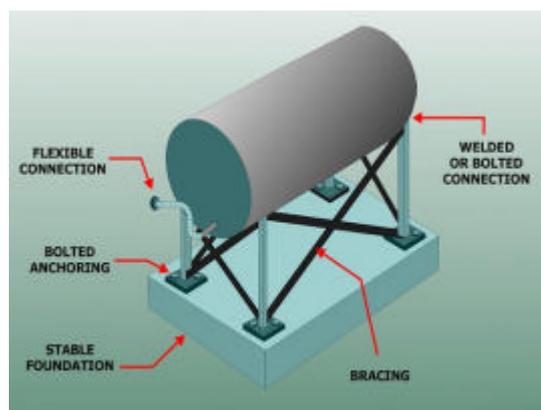
Photo 6: Water treatment tank which has a provision for bolting at the base but was found not bolted.

Fig 4: Bolting at the base can prevent overturning of heavy objects during an earthquake.

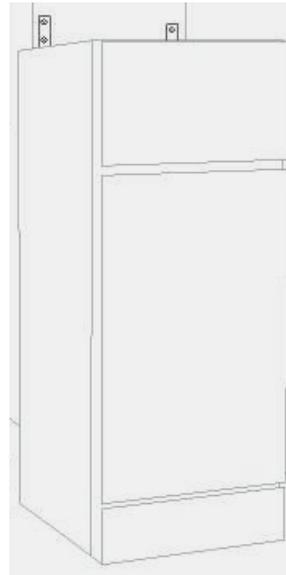
Photo 7: Tall and narrow objects like fridges can easily overturn during earthquakes.

Fig 5: Such objects can be protected from overturning by bolting them to the wall.

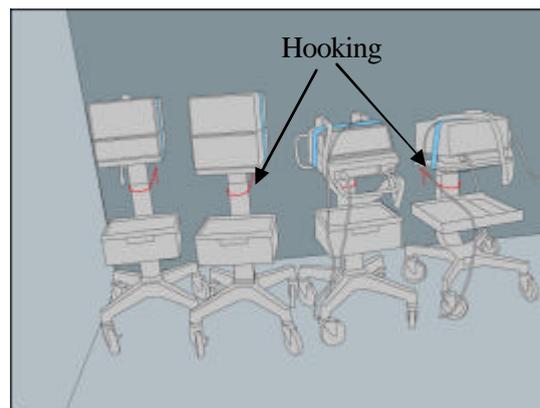
Photo 8: ECG monitors on rollers with potential risk of sliding and overturning.

Fig 6: Provision of chains on the wall to hook such machines.

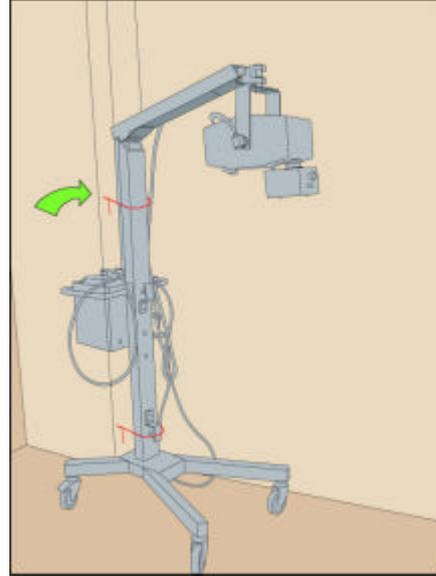
Photo 9: Mobile X-ray on rollers.

Fig 7: Hooking of mobile X-ray to the wall.

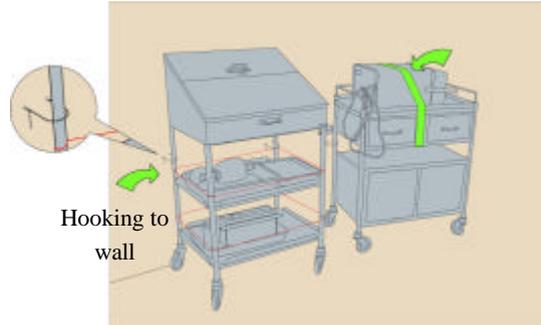
Photo 10: Resuscitation equipment on roller trolleys.

Fig 8: Hooking of the trolley and strapping of the equipment.

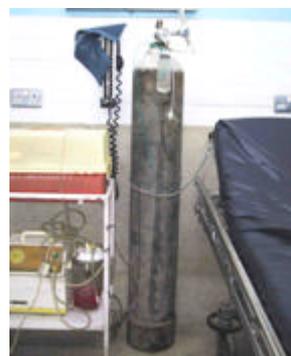
Photo 11: Un-hooked oxygen cylinders may fall over.

Fig 9: Hooking the cylinder with a chain can save the cylinder from falling.

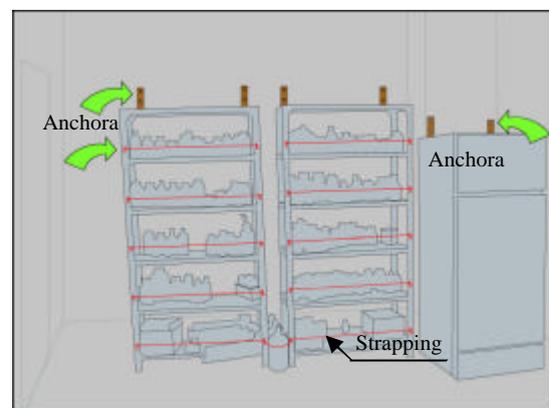
Photo 12: Chemical and medicine bottles on shelves pose a risk of falling.

Fig 10: Strapping the shelves by nylon rope after anchoring the rack to the wall is an easy way of making these bottles safe.

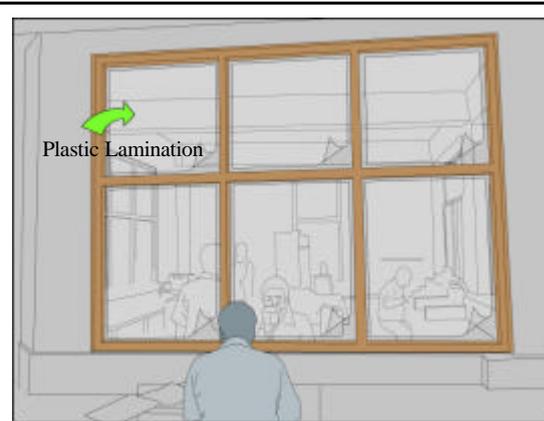
Photo 16: This window glass can cause a life safety hazard.

Fig 12: Simple plastic lamination can protect lives.

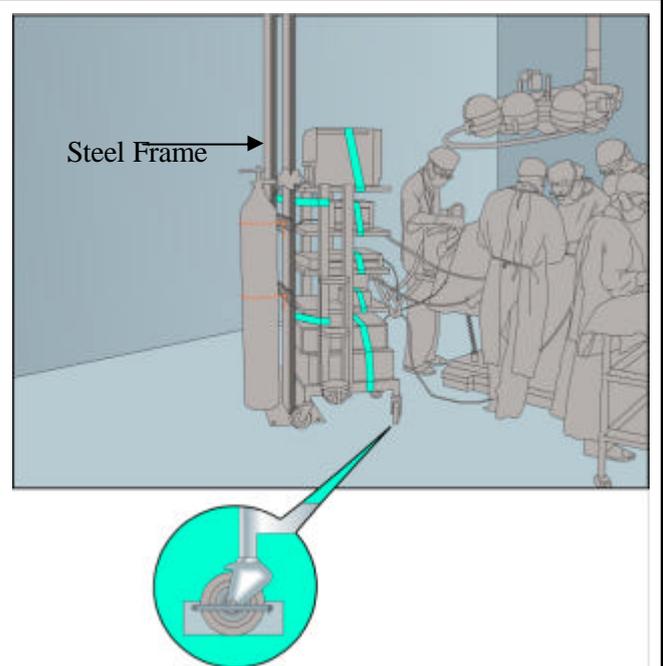
Photo 17: Most equipment is on roller trolleys (equipment racks) in operation theatres. The risk of falling down is high.

Fig 13: Tying all equipment to a steel frame can improve the situation.

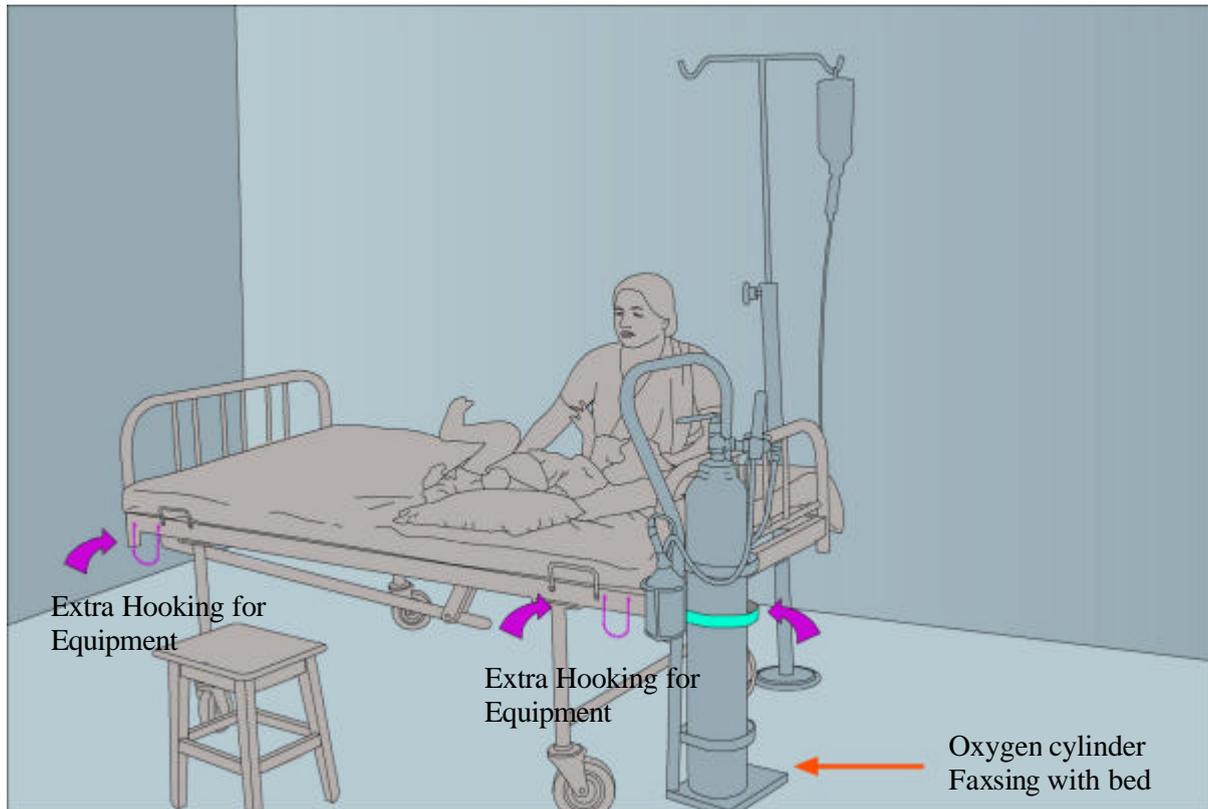
During the survey, it was found that in important wards like ICU, CCU, post operative, and maternity wards the equipment and the accessories needed for the treatment are generally placed near to the beds but without any anchor or support. This equipment and accessories should be fixed to reduce the vulnerability and enhance the hospital performance after an earthquake. Providing chains and anchor hooks on each bed could solve the problem.
